Federal Creosote Superfund Site OU3 - Rustic Mall Remedial Action Report

August 2008

REMEDIAL ACTION REPORT

**OU3 - RUSTIC MALL REMEDIAL ACTION
FEDERAL CREOSOTE SUPERFUND SITE
MANVILLE, NEW JERSEY**

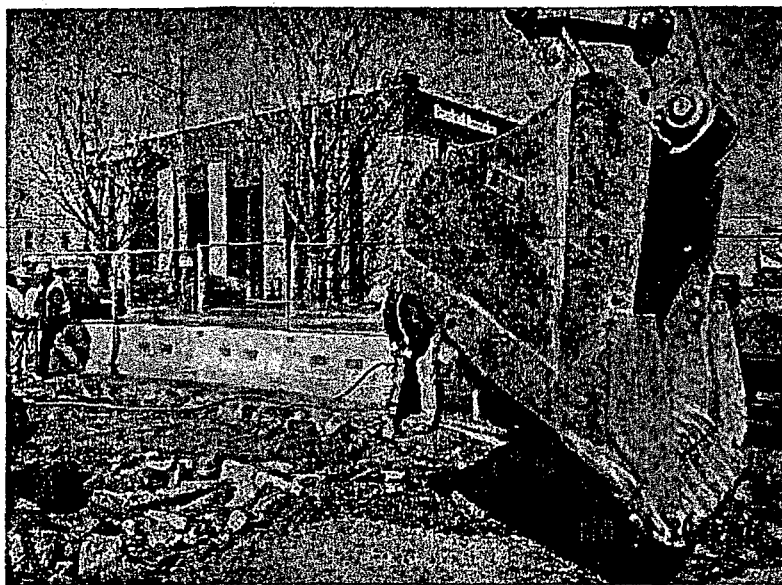
Photo 3-1 - Pavement Removal

Remedial excavation required the removal of at-grade features such as pavement, curbs, gutters, sidewalks, driveways, and walkways. In addition, above-ground items such as fences, gates, site lighting, and traffic signs were removed. Demolition of the Rustic Mall

buildings that contained a supermarket and other businesses was conducted by the Rustic Mall property owners during the course of remedial construction. The demolition and removal of above-ground portions of the buildings was completed entirely without EPA involvement. Once buildings were demolished to the slab, foundation and slab removal was conducted by SES as excavations progressed.

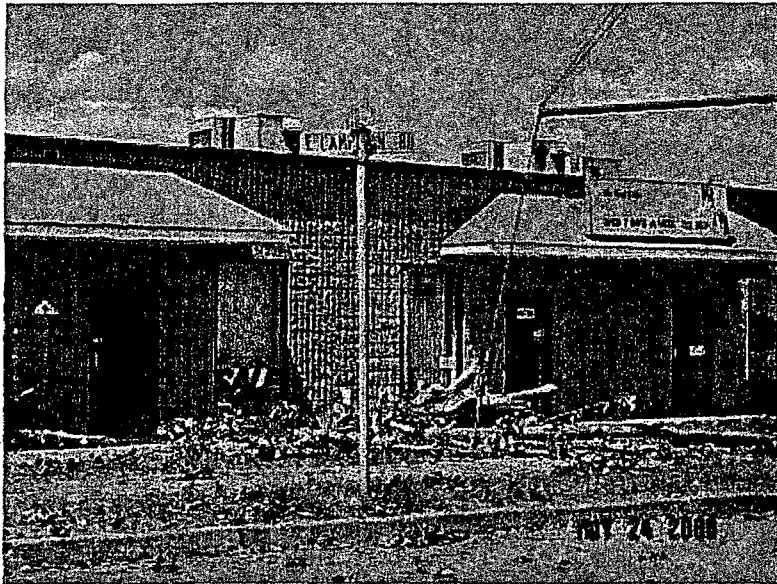
Photo 3-2 - Site Clearing

Clearing and grubbing was conducted as needed for the remedial construction. Stumps from grubbing operations were decontaminated and disposed of as construction and demolition debris.

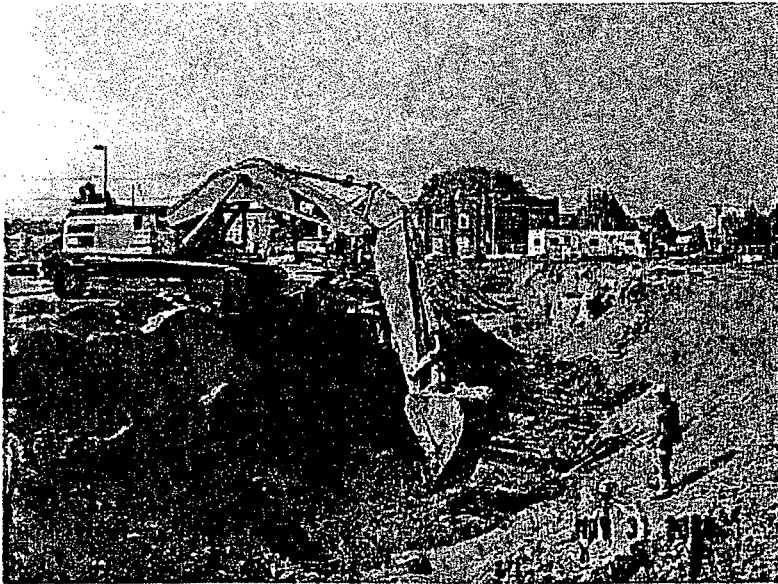
Photo 3-3 - Excavation Operations

The excavation was organized into four areas: South, Southwest, and two North Areas (North Area 1 and North Area 2). SES excavated to the limits in the South, Southwest, and North Areas of the Rustic Mall as shown on the contract drawings. Upon completion of excavations, SES inspected both the sidewall and the bottom of the excavated areas for visible sign of contamination. If contamination was suspected, the Contracting Officer was notified and SES proceeded as directed. A total of 177,846.16 tons of soil was excavated and transported off site for disposal.

Excavation was completed in phases throughout the Rustic Mall in order to minimize the impact to the businesses that were operating at the time. The sequence of the excavation was as follows: North Area 2, Southwest Area, North Area 1/Central Area, South Area. At the beginning of excavation in North Area 2, the building demolition was uncertain; therefore, the original limits of excavation were such that the building could remain if the owners did not demolish it. Excavation limits in North Area 2 and the South Area were changed during the design as the building footprint became available for investigation and design.

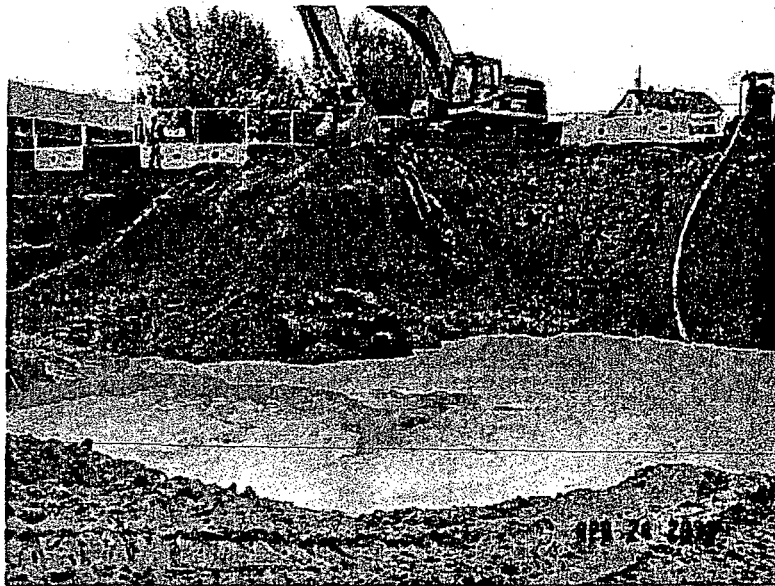
Photo 3-5 - Dewatering

Perimeter dewatering system was not necessary during the Rustic Mall remediation since the excavations were relatively shallow. Perched water encountered during the excavation as well as surface runoff that accumulated within the excavation areas was pumped out as needed and treated at the on-site wastewater treatment plant prior to discharge.

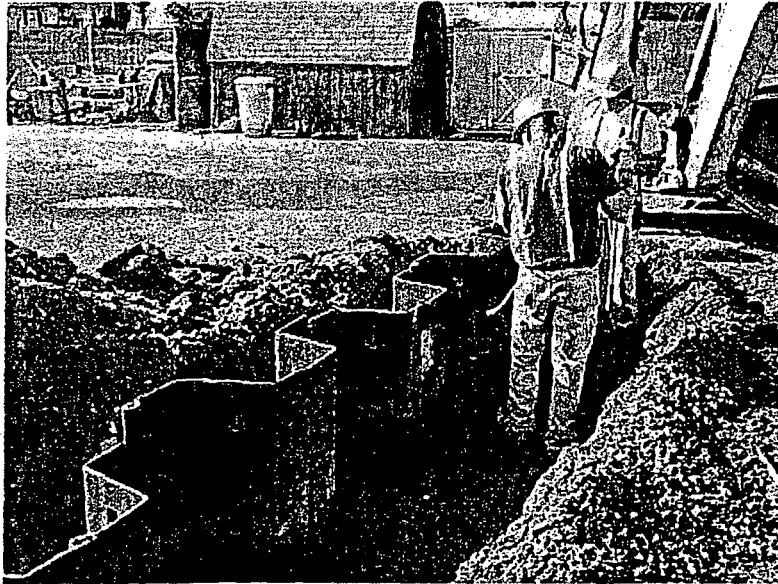
Photo 3-6 – Excavation Support System (Sheeting)

A 1:1 slope system was established for excavations deeper than four feet bgs. When excavation was directly adjacent to structures' foundations, a 1.5 horizontal to 1 vertical was established for excavations greater than ten feet bgs and a 1:1 slope system was established for excavations of ten feet bgs or less.

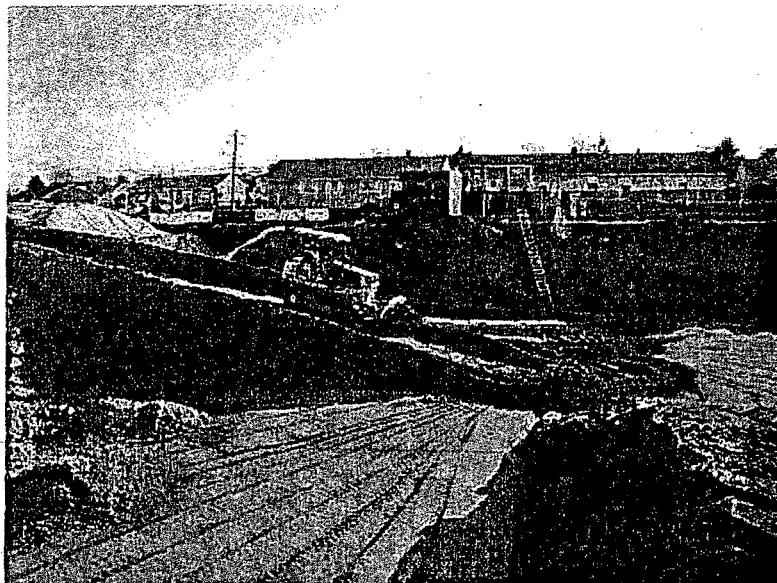
Photo 3-7 - Backfill Operations

SES backfilled the excavated areas using clean imported backfill material from several sources including Tomkat Construction, Inc., Stavola Construction Materials, Maddox Materials, LLC, and Excavating Material & Equipment, Inc. (EME). Prior to delivery to the site, physical and chemical analyses were performed on every 5,000 CY lot of material to ensure that backfill materials met the project requirements and specifications. All backfill material placed at the site met NJDEP residential direct contact cleanup criteria.

Backfill material was placed directly in the excavation and spread in horizontal layers up to 8 inches thick utilizing bulldozers. Placed material was compacted by utilizing an SD-40D roller to a minimum of 95% of its maximum dry density by Standard Proctor (ASTM D-698). Hand compactors and/or vibratory plates were utilized to compact areas immediately adjacent to houses or other structures. Compaction and moisture content testing of the backfill material was performed by Craig Testing Laboratories, Inc. located in Mays Landing, New Jersey. Approximately 154,383.98 tons of common fill and 14,030.68 tons of Dense Graded Aggregate (DGA) were utilized to fill the OU3 excavation areas. The backfill quantity in tons is lower than the excavation quantity for several reasons. First, the excavation quantity includes slab and foundation debris. Second, there is a difference between pre-excavation and final grades due to removal of the buildings. The final grade is lower than the pre-excavation grade.

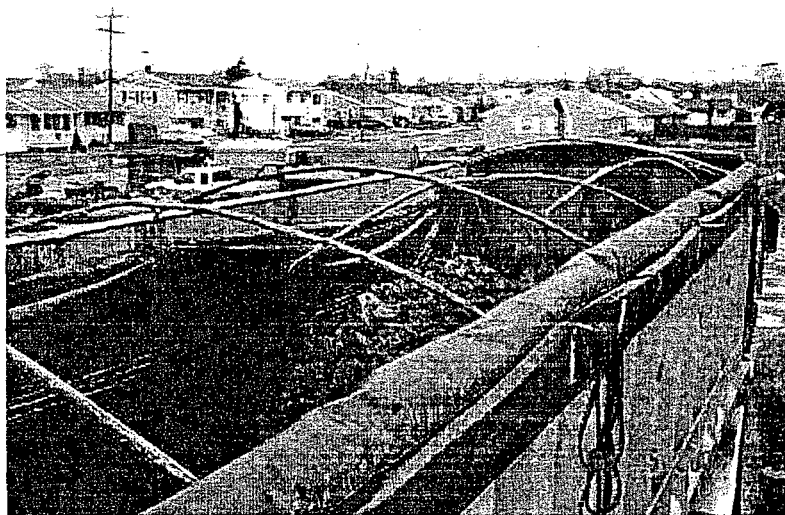
Photo 3-9 – Waste Hauler

Material to be disposed of at Subtitle C and D facilities were transported to their respective facilities by utilizing 70,000-lb triaxle dump trucks. Material requiring thermal treatment and disposal was loaded into 80,000-lb dump trailers for transportation to the thermal treatment facility. Trucks transporting excavated material to the Subtitle C and thermal treatment facilities were required to be lined, and all trucks were tarped and decontaminated (tire wash) prior to leaving the site.

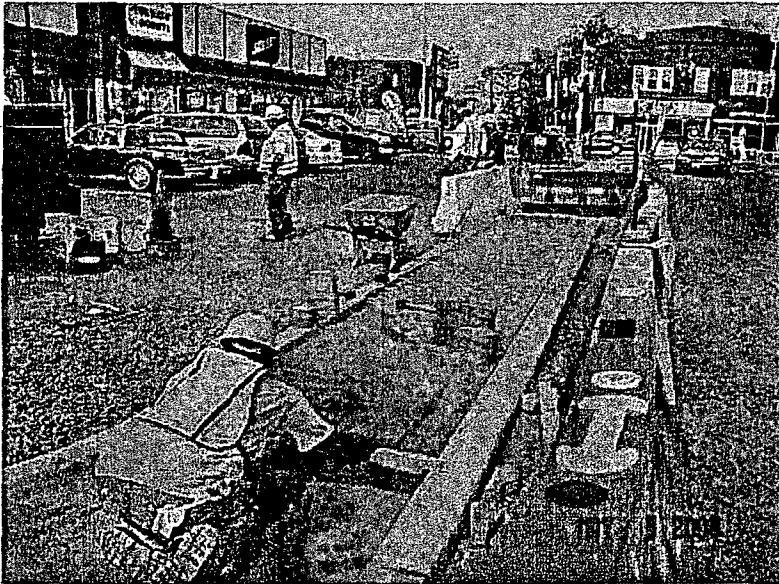
Photo 3-11 - Concrete Island Restoration

manholes that were disturbed or removed during construction as shown on the restoration plans included in the contract drawings. Utility service laterals extending to businesses that remained in operation, which were impacted by the excavation were also restored. Utility work was performed by the respective utility companies or their authorized representatives, except for water, sanitary, and storm sewer work, which was performed by SES. The restoration plans also include restoring the area currently occupied by the Support Zone and WWTP. The asphalt pavement in the portion of this area that lies outside of the excavation limits was milled and replaced by dense graded aggregate. Grading in this area has been altered to improve the drainage from the existing condition. In addition, as requested by the Borough of Manville, the entrance to the alleyway in the South Area was not restored to the previous condition. Instead, a continuous 6-inch high curb was placed along the north curb line of East Camplain Rd. to eliminate the entrance at this location.

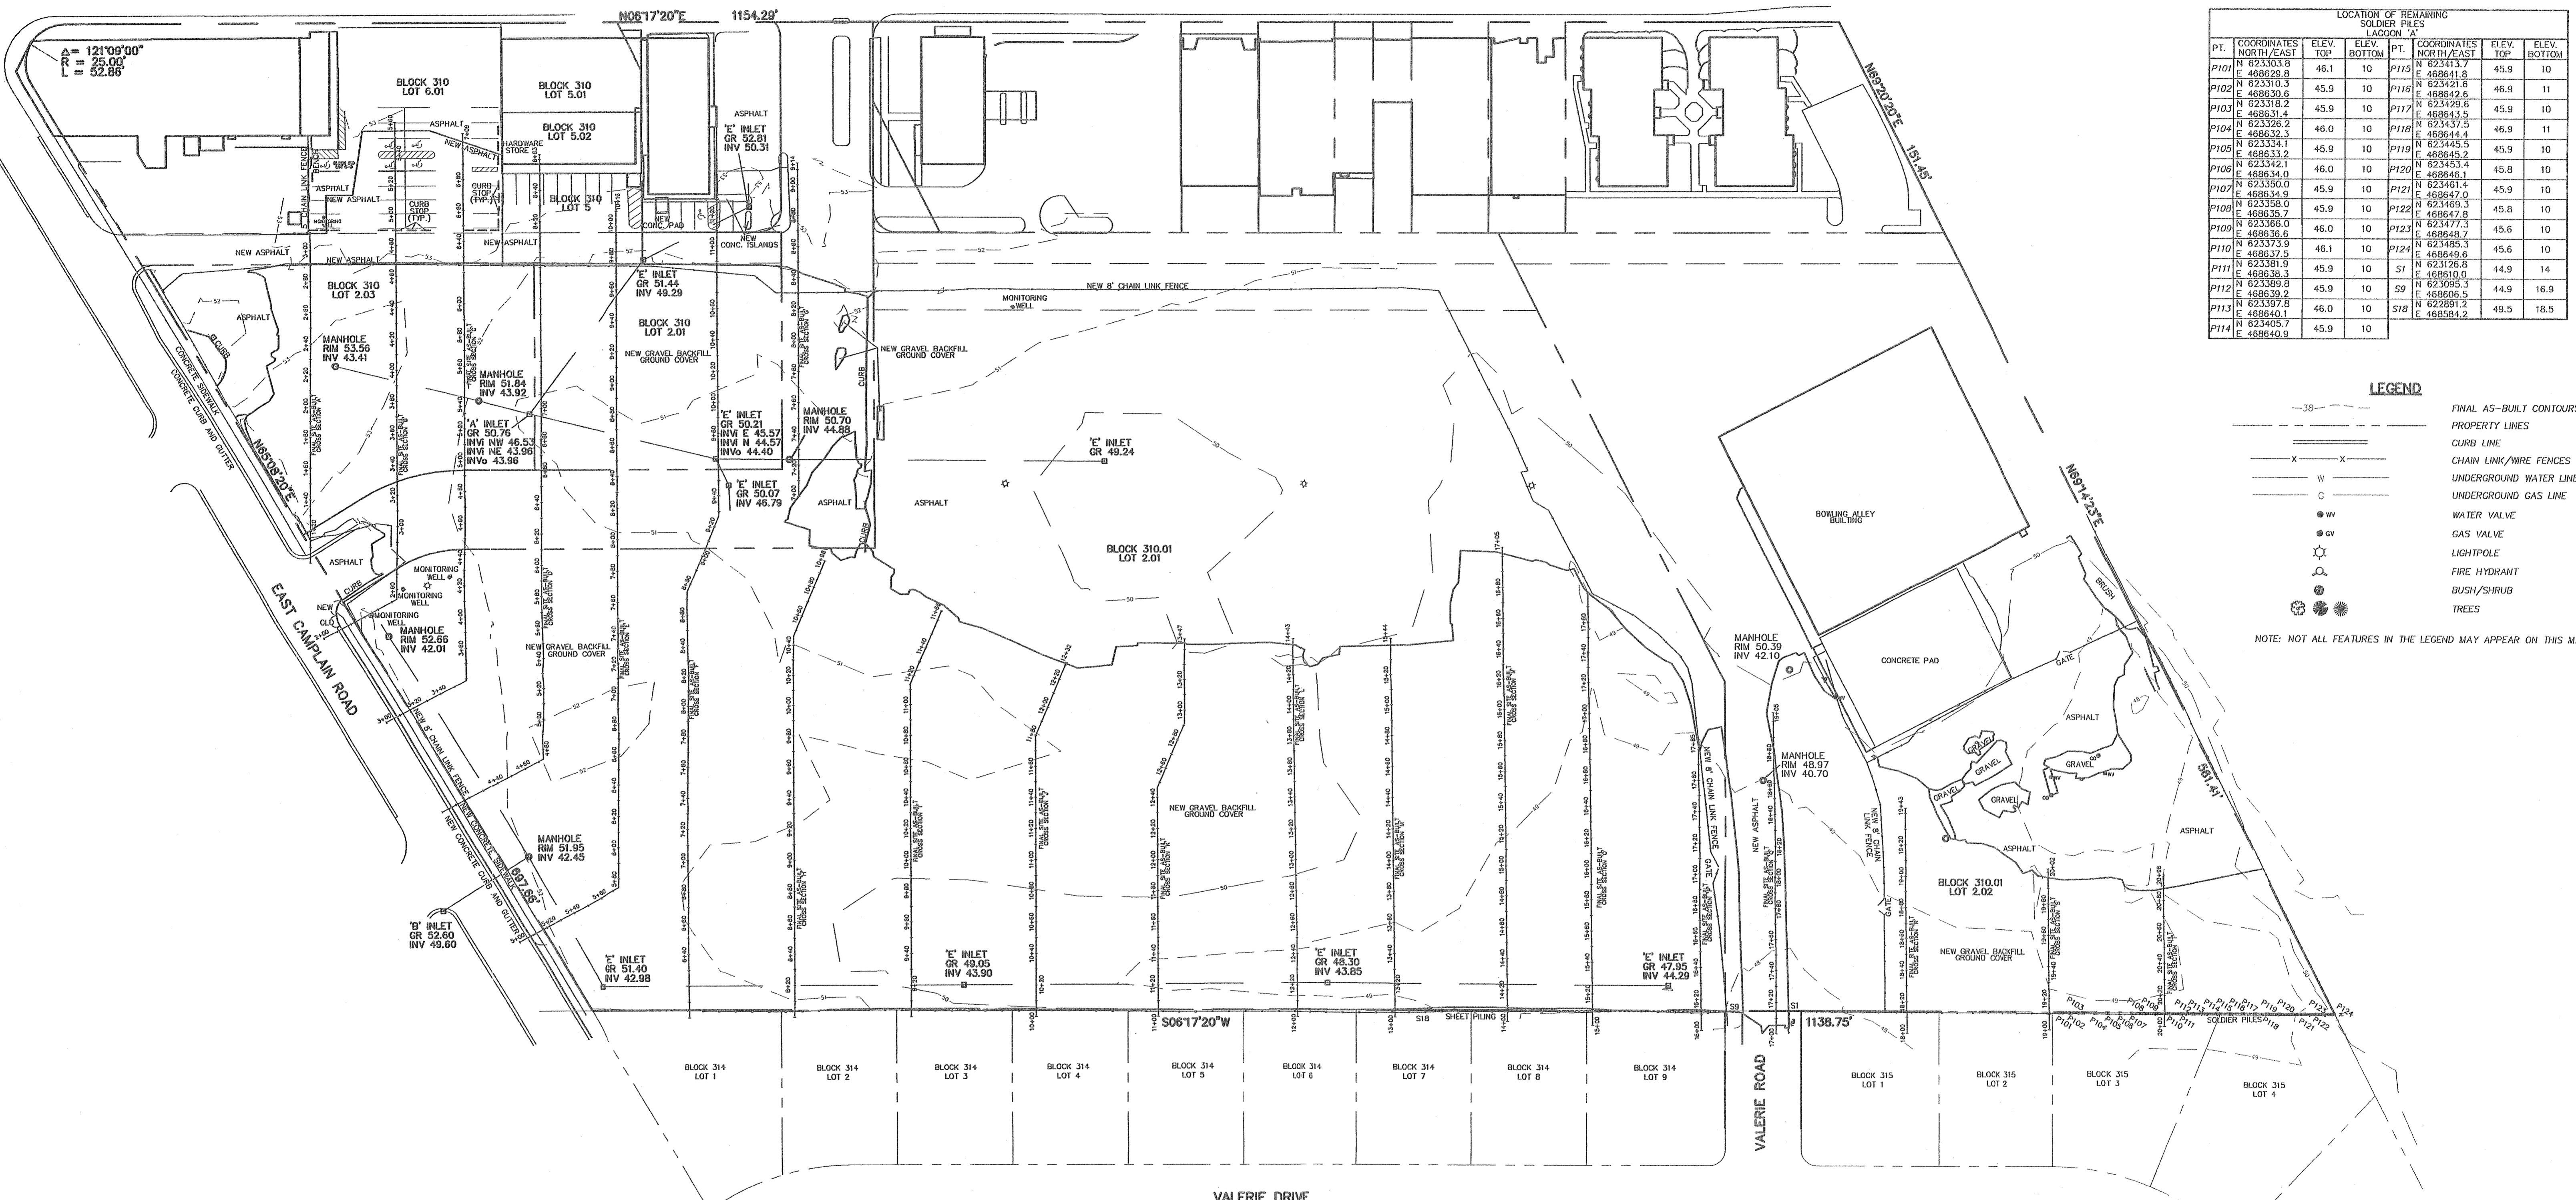
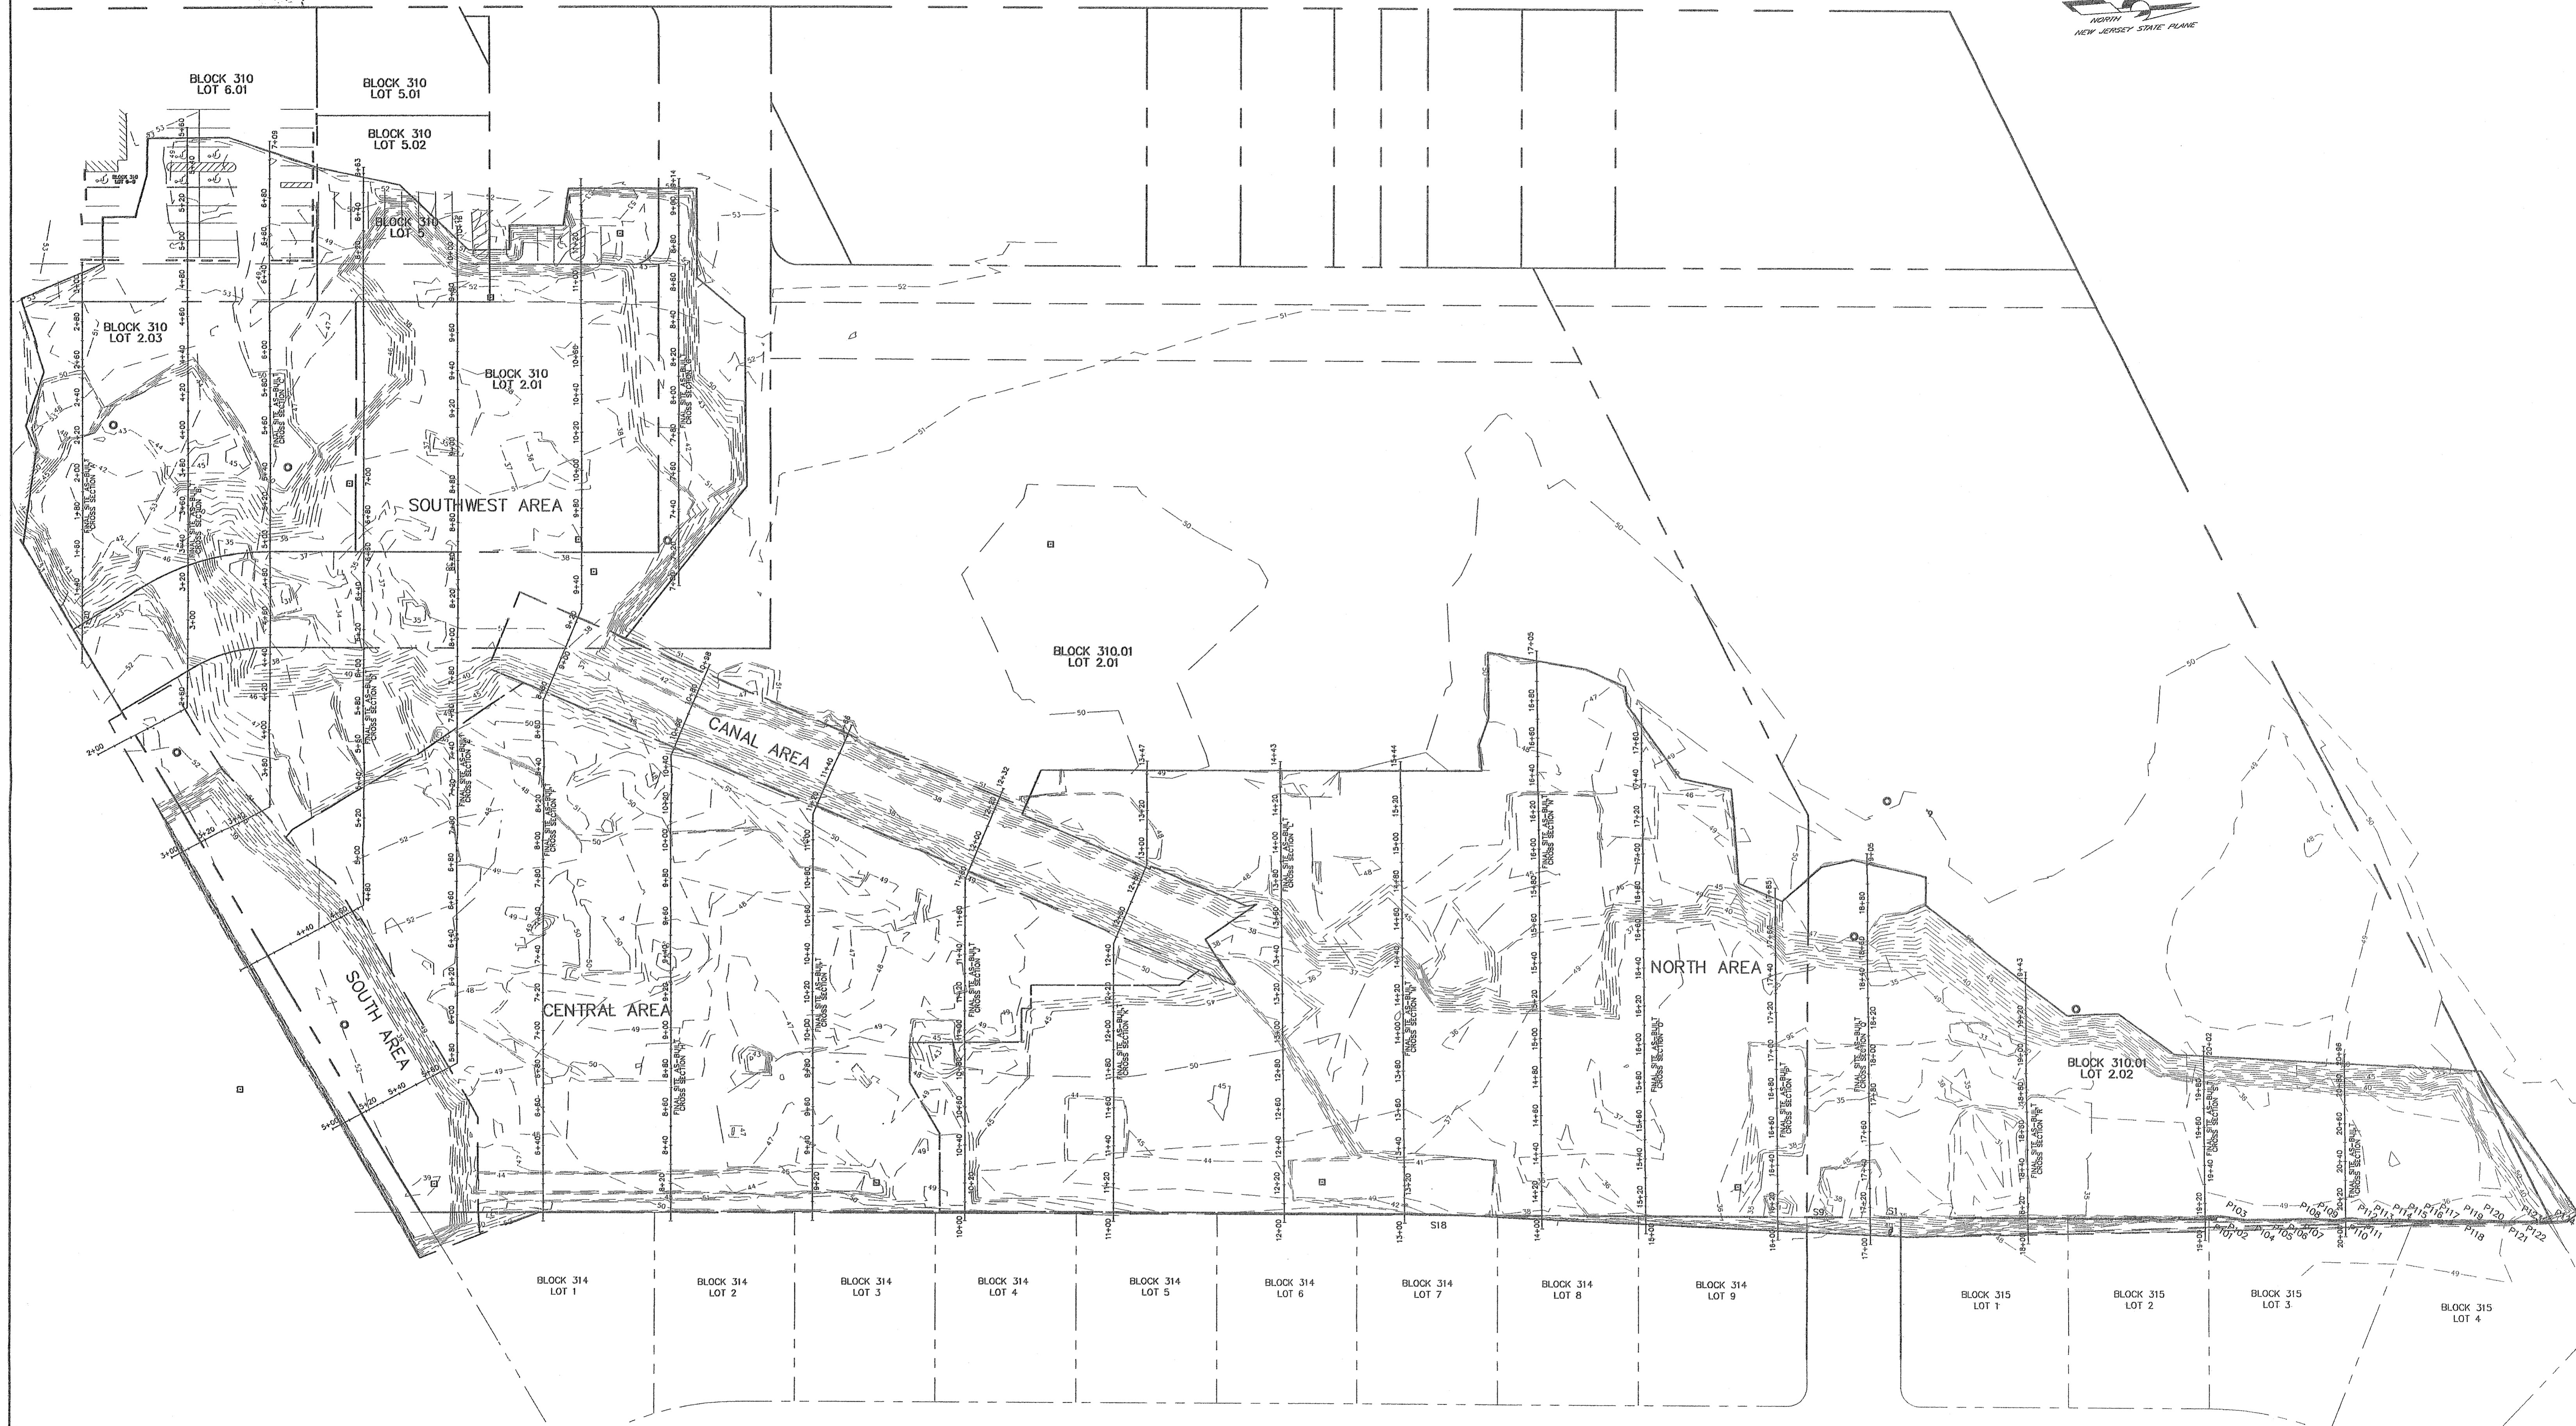
FINAL SITE AS-BUILTS

1. THIS MAP WAS CREATED TO SHOW THE AS-BUILT CONDITIONS AS OF JUNE 2008 AND SHOULD NOT BE USED FOR OTHER THAN ITS INTENDED PURPOSE.
2. PHYSICAL FEATURES SHOWN HEREON REPRESENT PRE CONSTRUCTION CONDITION UNLESS SPECIFICALLY NOTED AS NEW.

Final as-built survey depicts the post-remediation conditions and final topography of each remediated property. Excavation as-built survey was also performed and excavation cross sections were prepared. Copies of as-built drawings are included in Appendix C. Final survey was performed by Kennon Surveying Services, Inc. of Warren, New Jersey, a New Jersey licensed land surveyor.

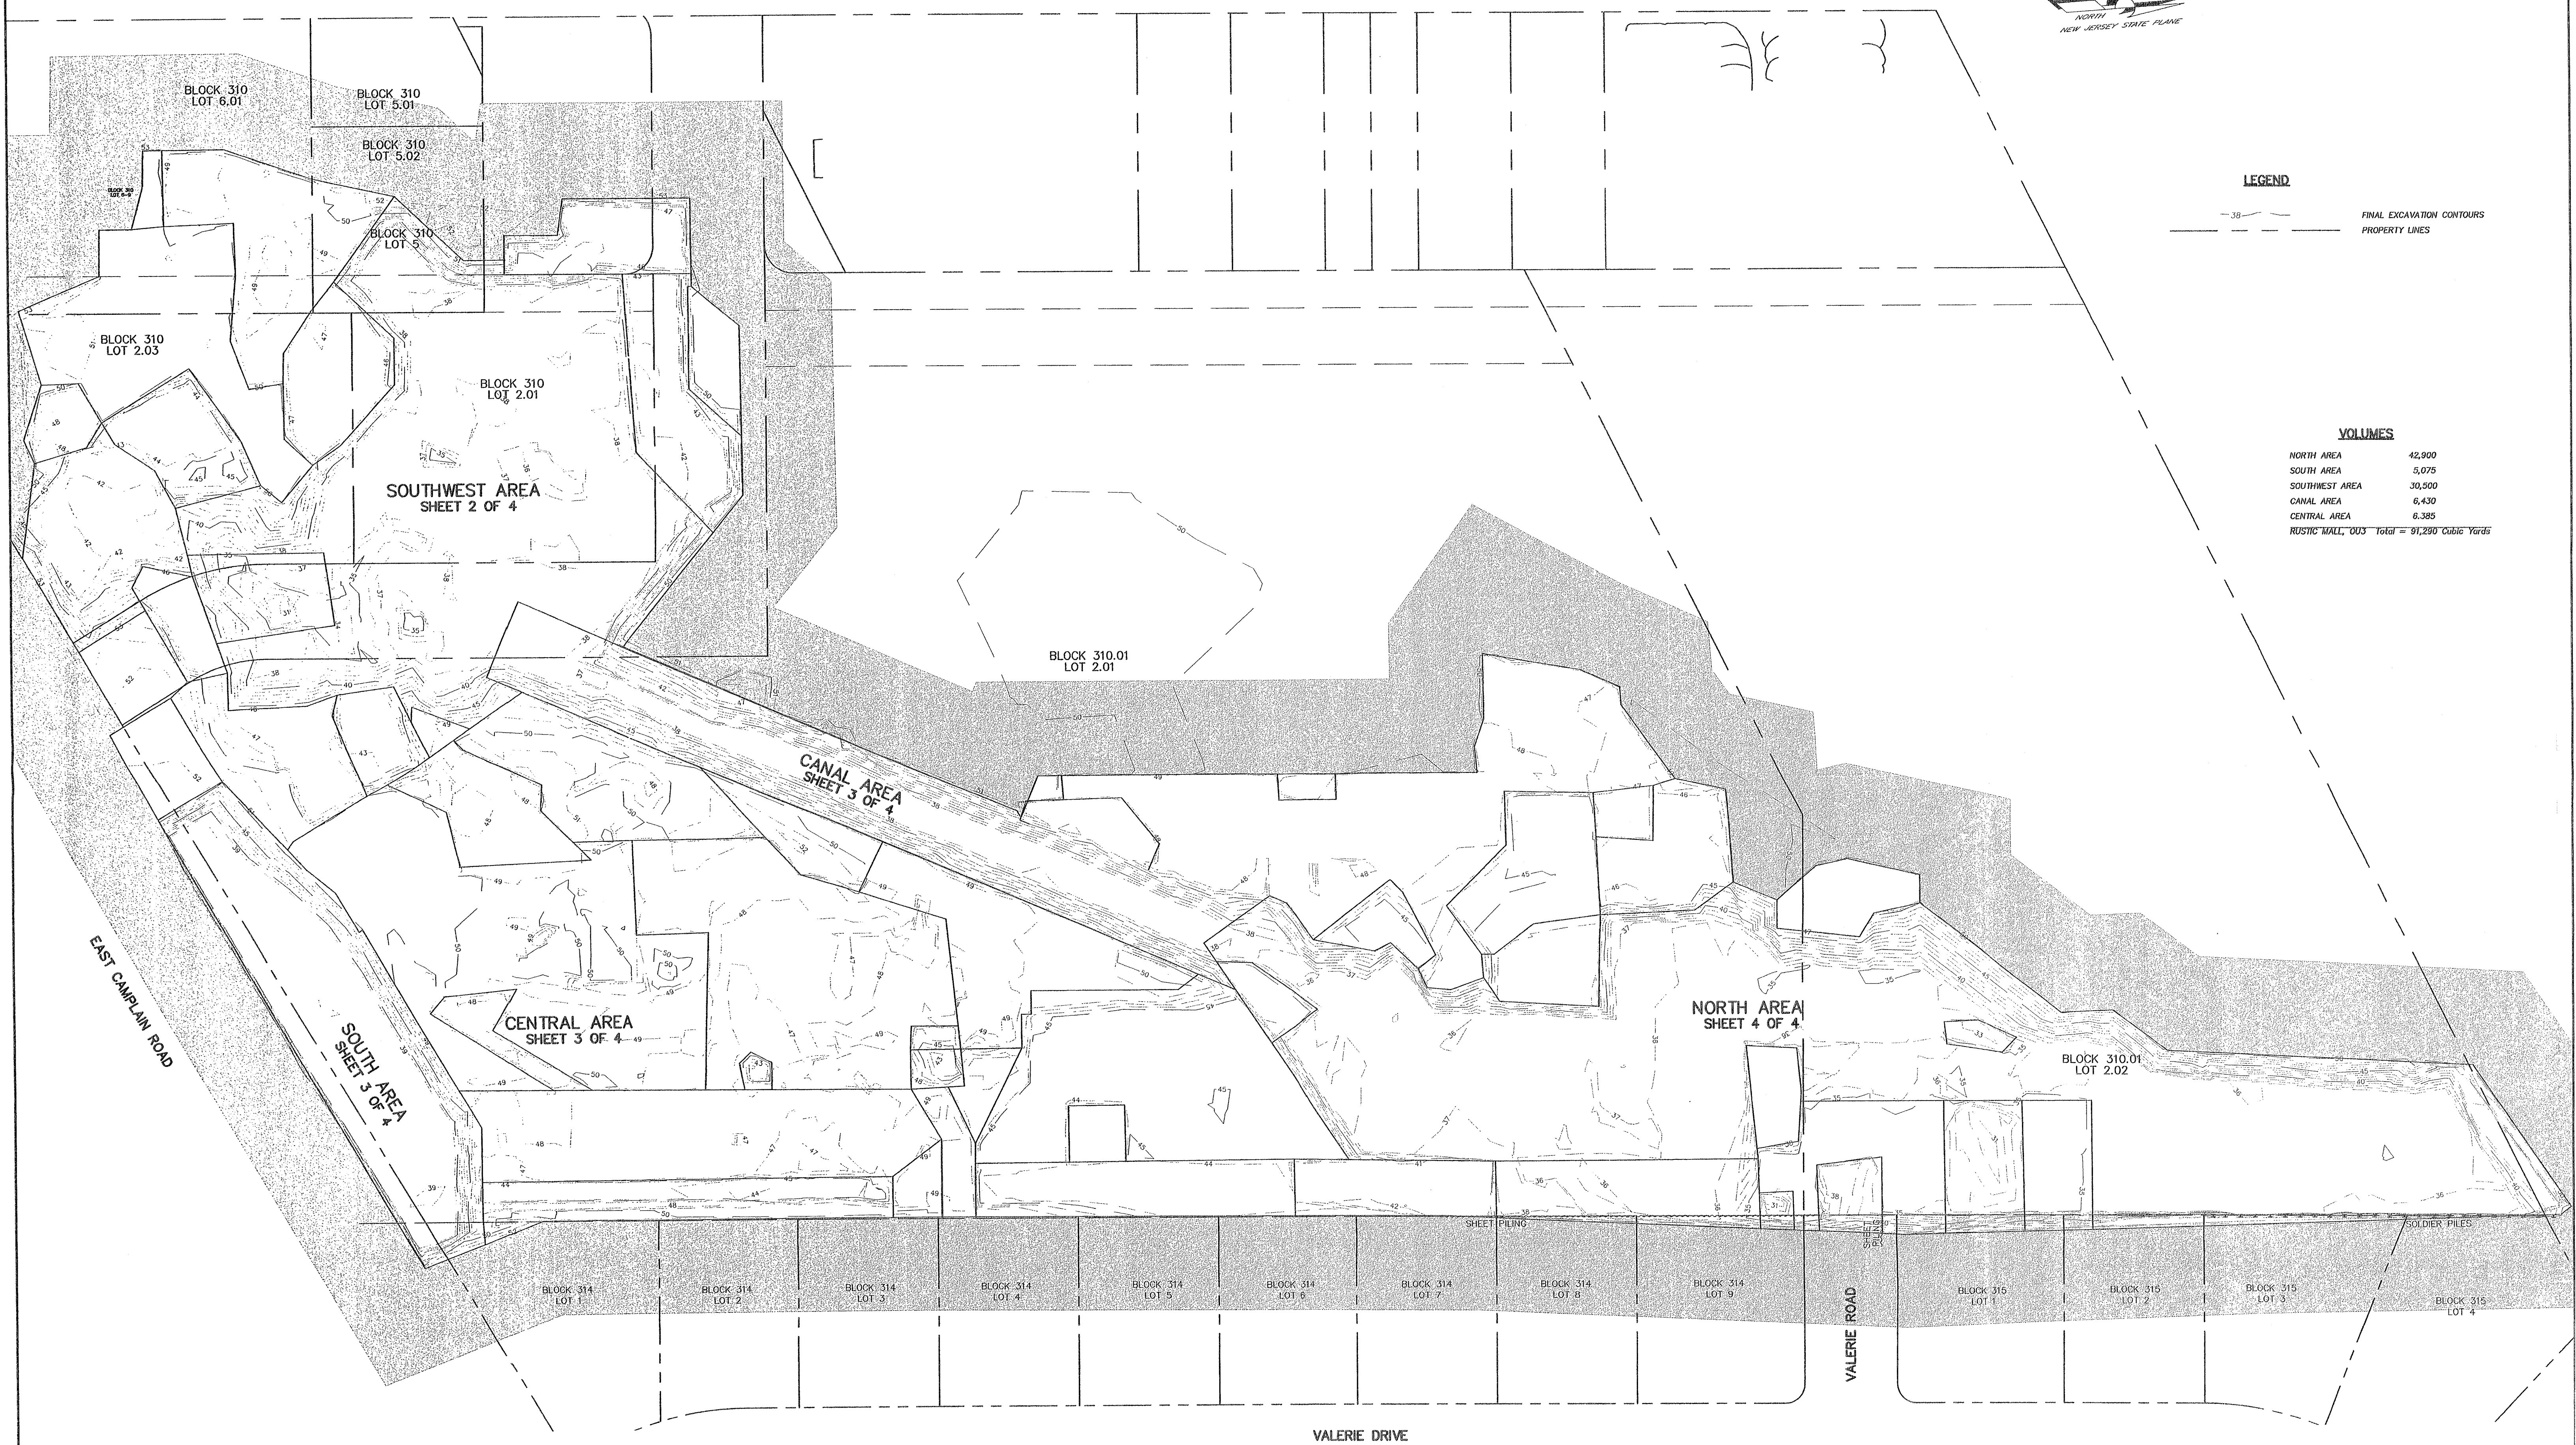
FINAL EXCAVATION LIMITS

NORTH AREA	42,900
SOUTH AREA	5,075
SOUTHWEST AREA	30,500
CANAL AREA	6,430
CENTRAL AREA	6,385
RUSTIC MALL, OU3 Total = 91,290 Cubic Yards

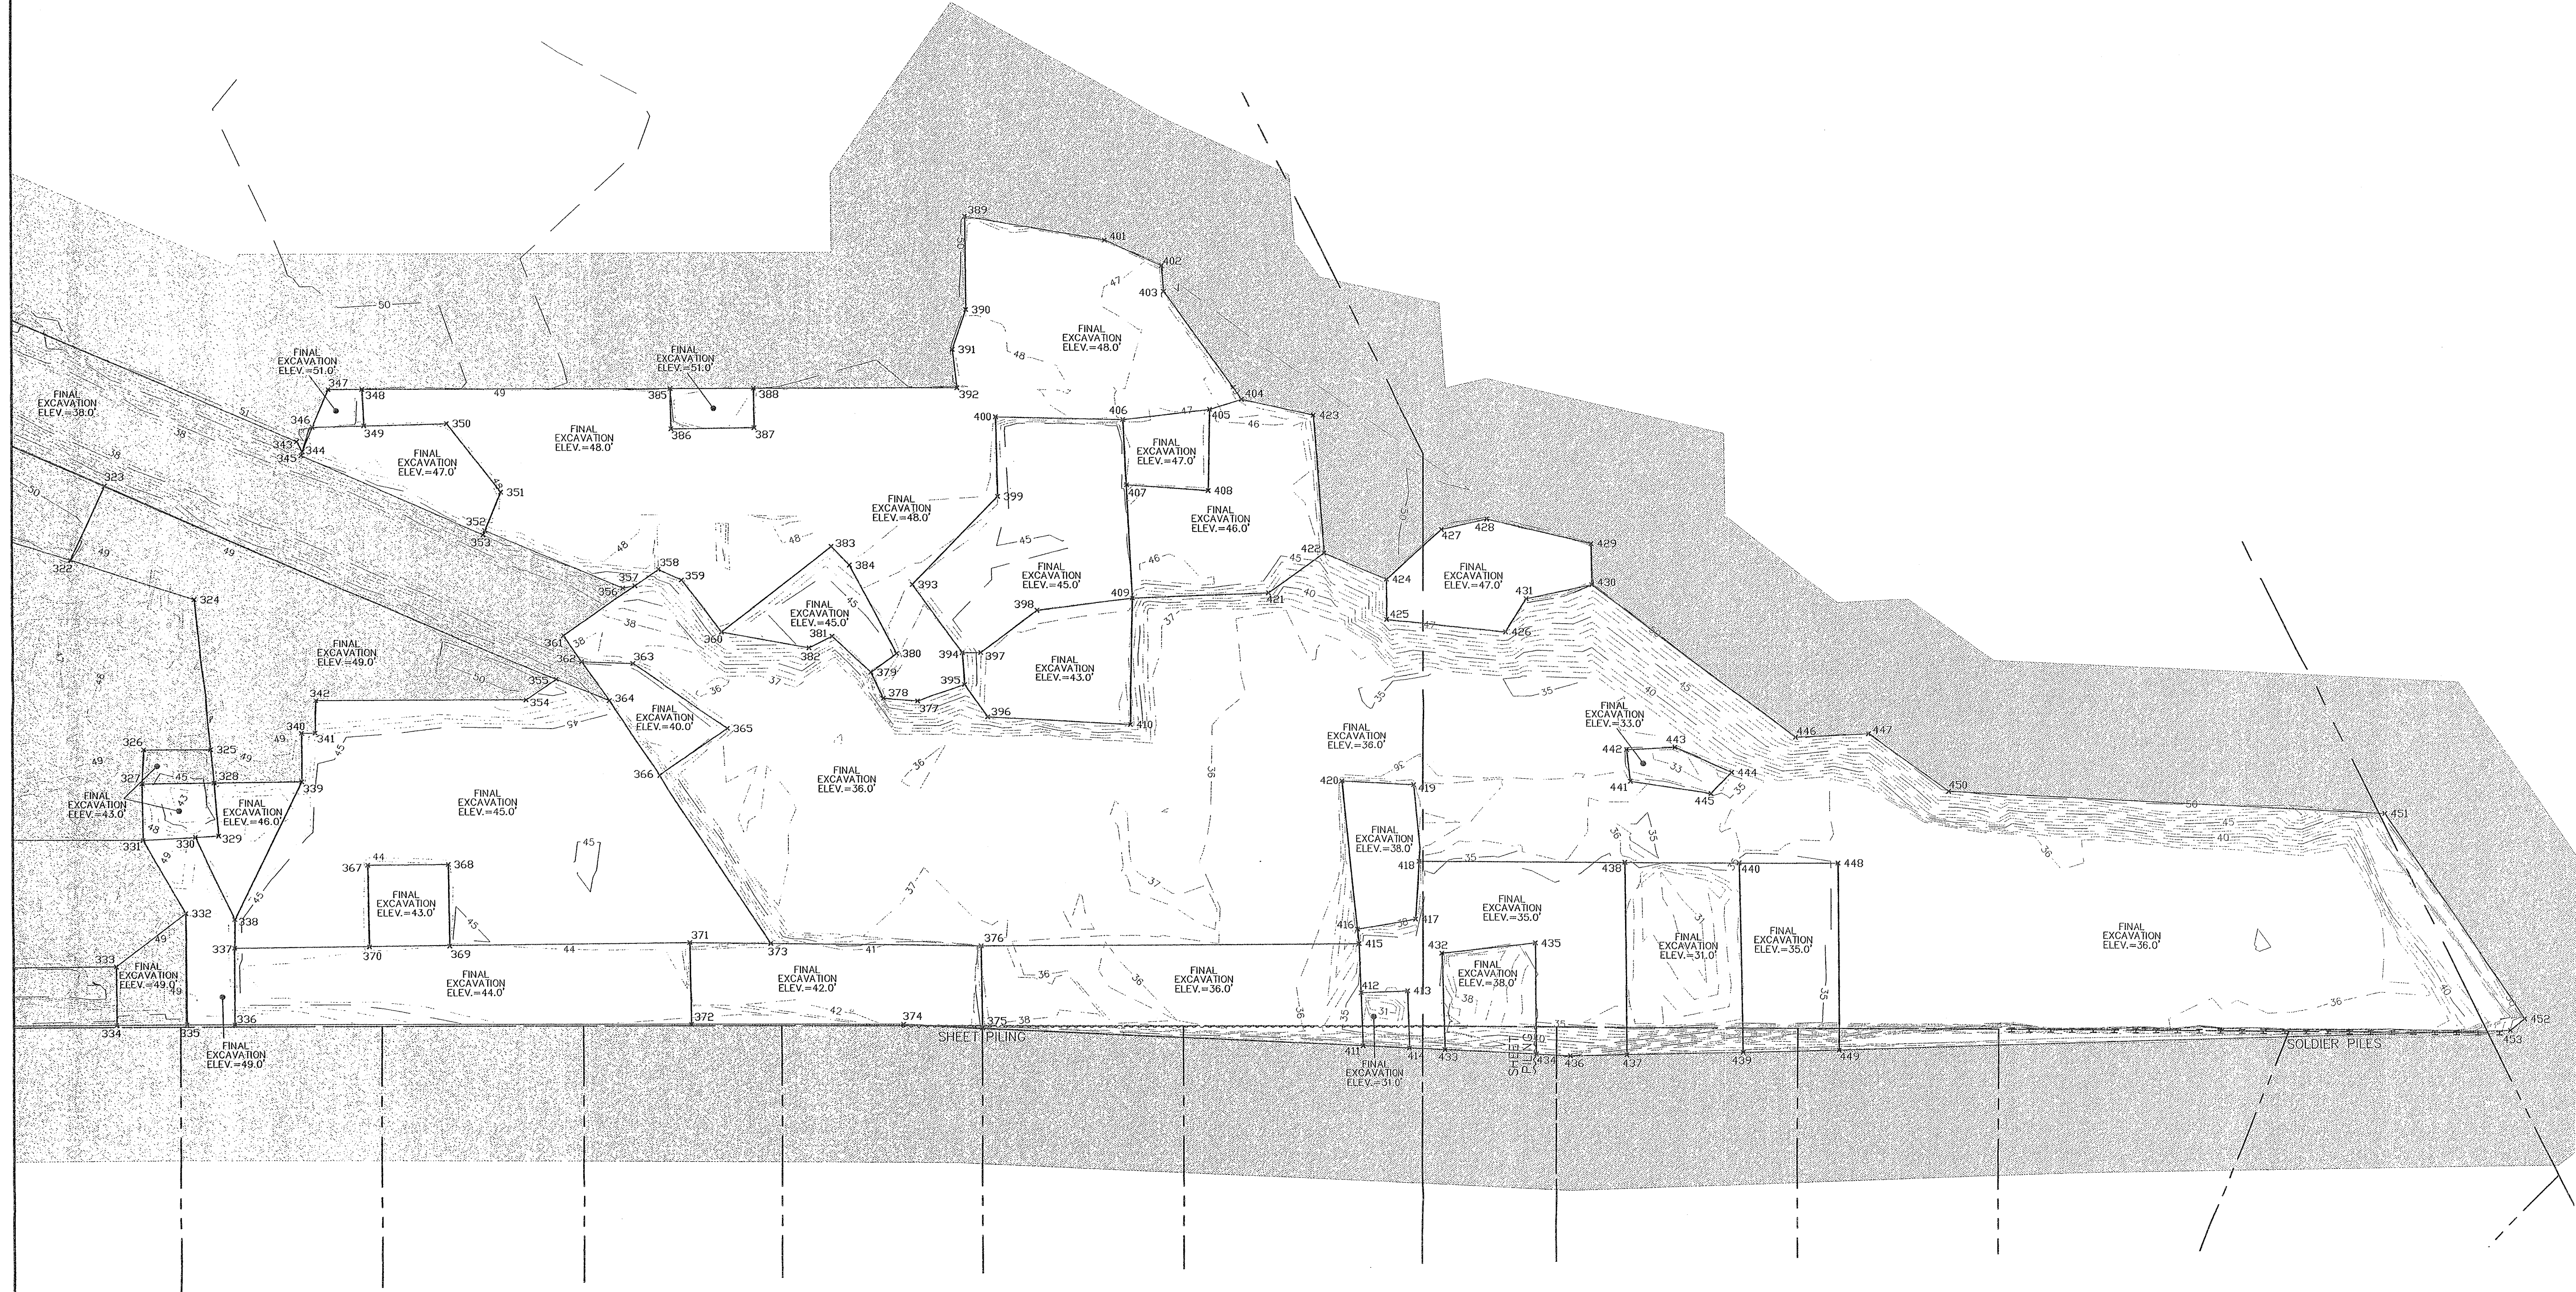
--- 38 --- FINAL EXCAVATION CONTOURS
--- PROPERTY LINES

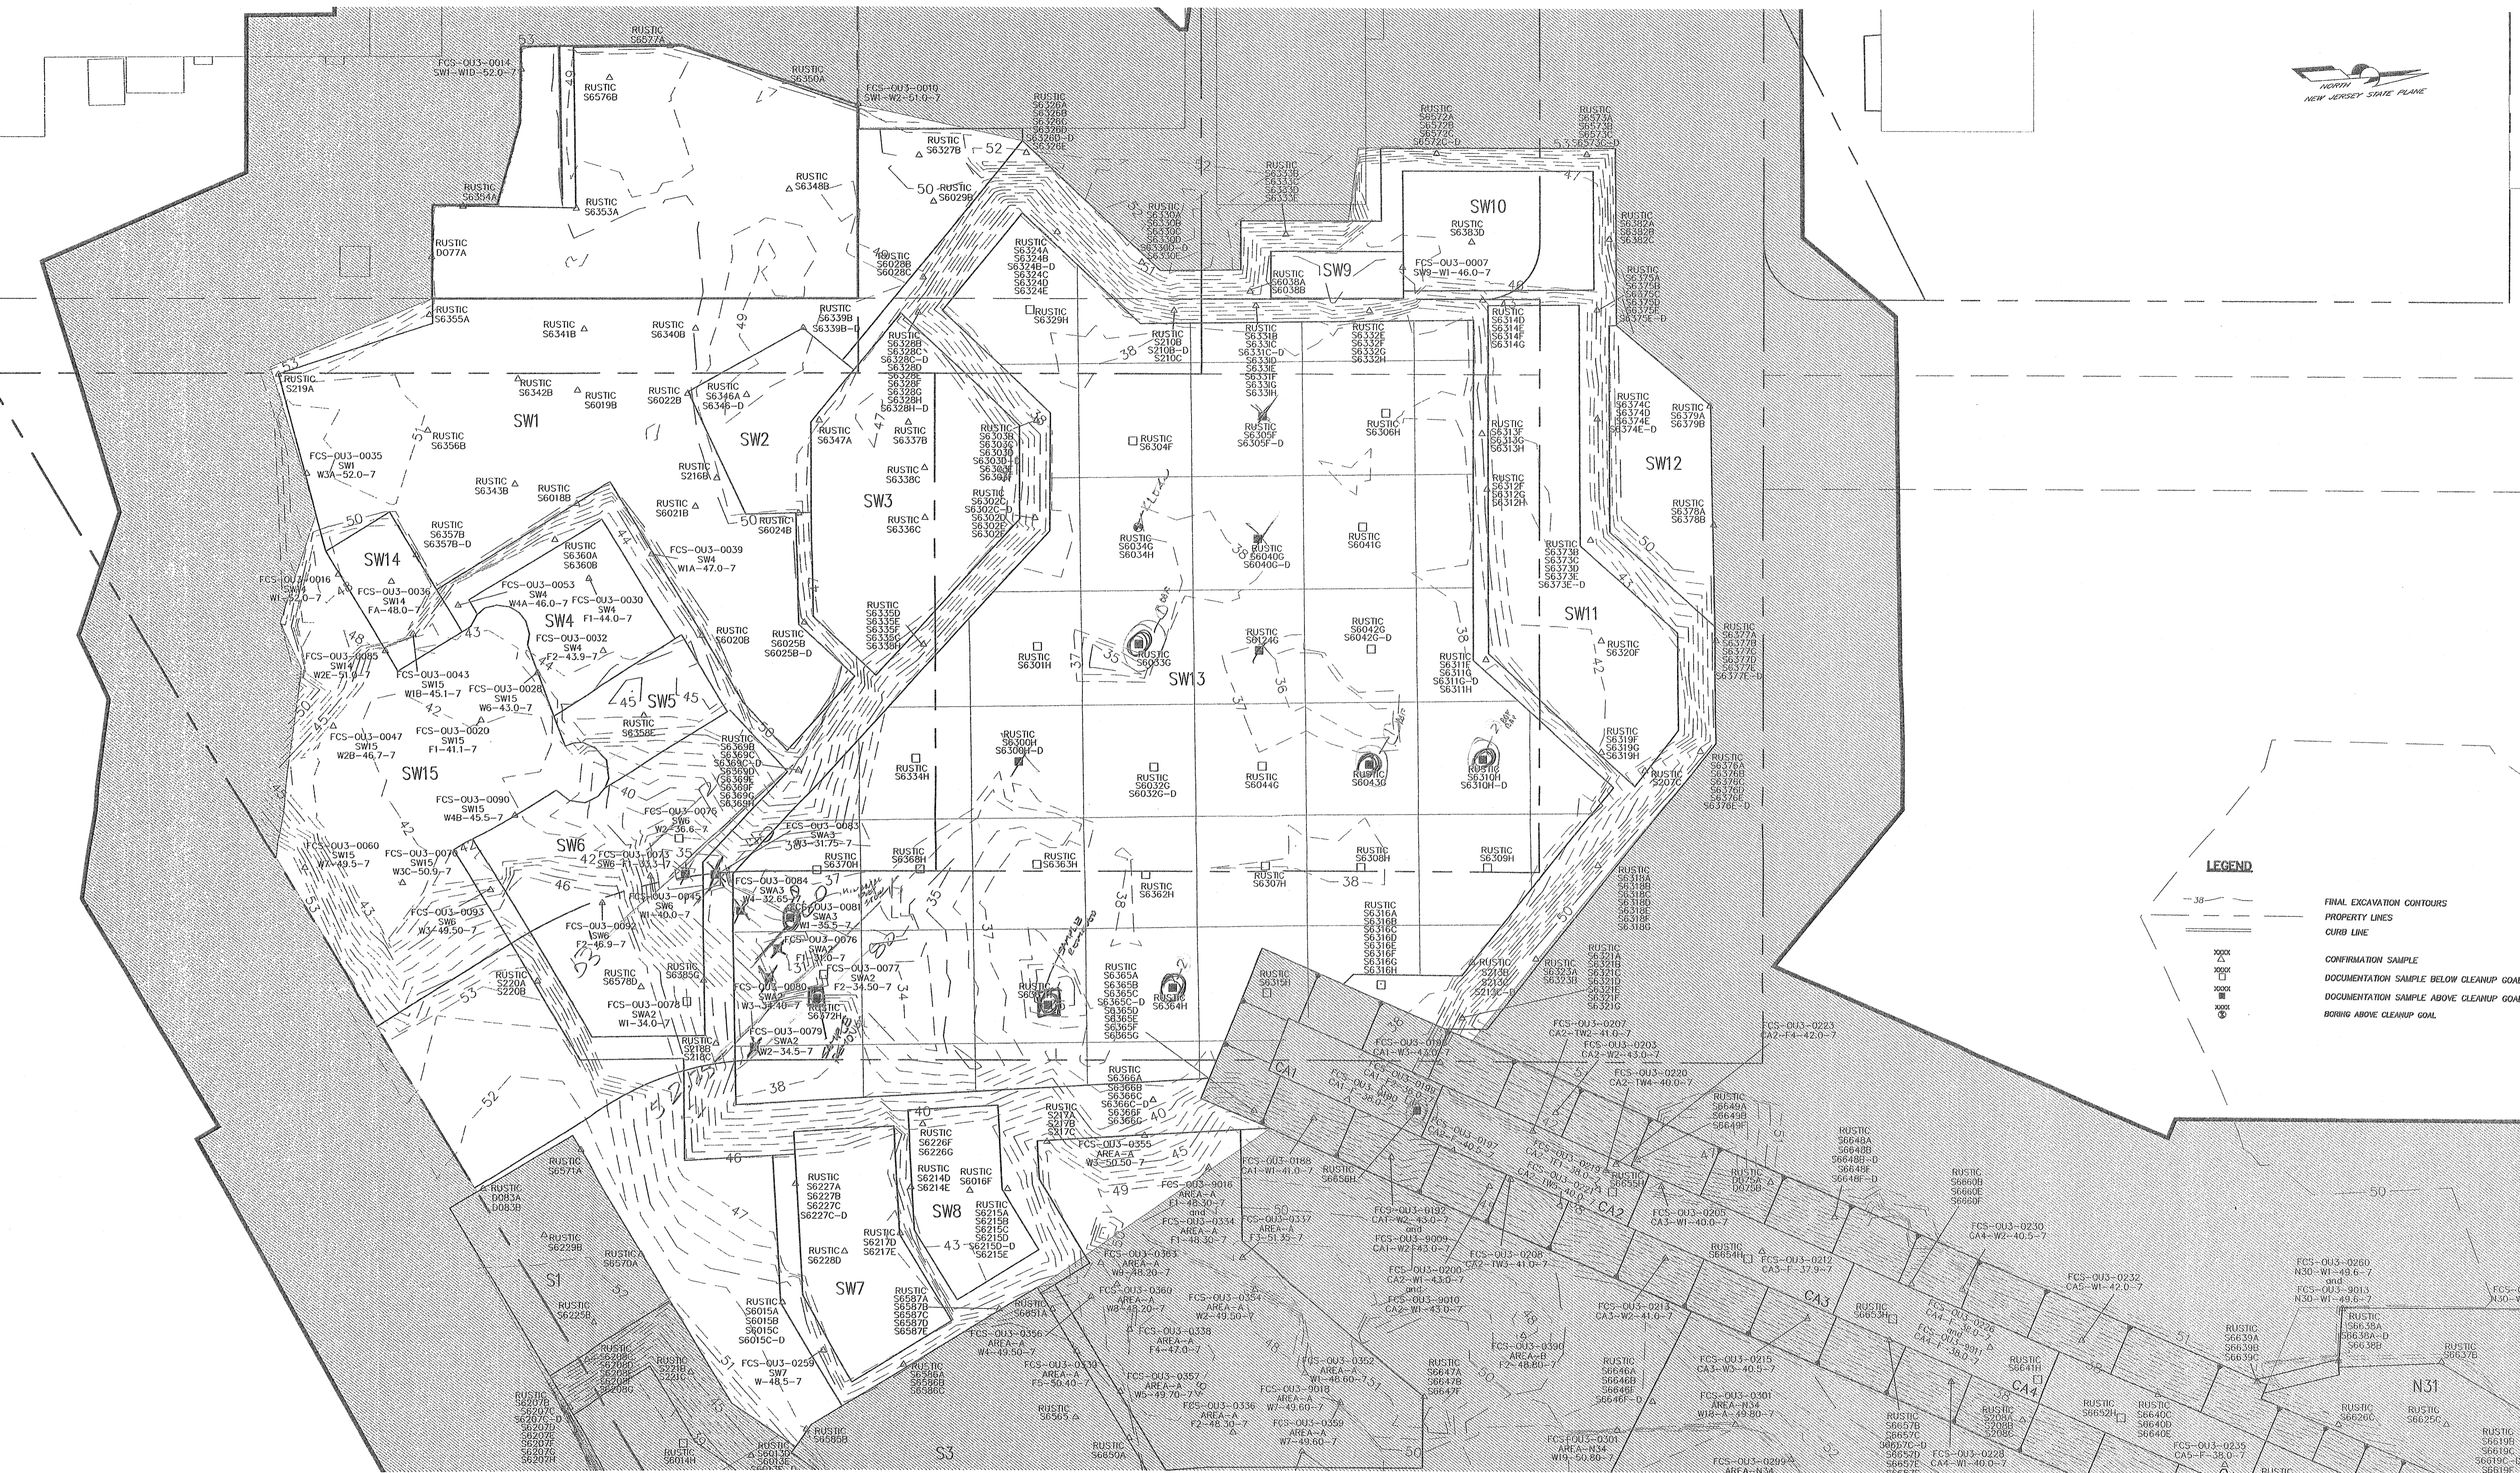
FINAL EXCAVATION CONTOURS
PROPERTY LINES
CURB LINE

CONFIRMATION SAMPLE
DOCUMENTATION SAMPLE BELOW CLEANUP GOAL
BORING ABOVE CLEANUP GOAL
